# Public Document Pack

## Notice of Meeting

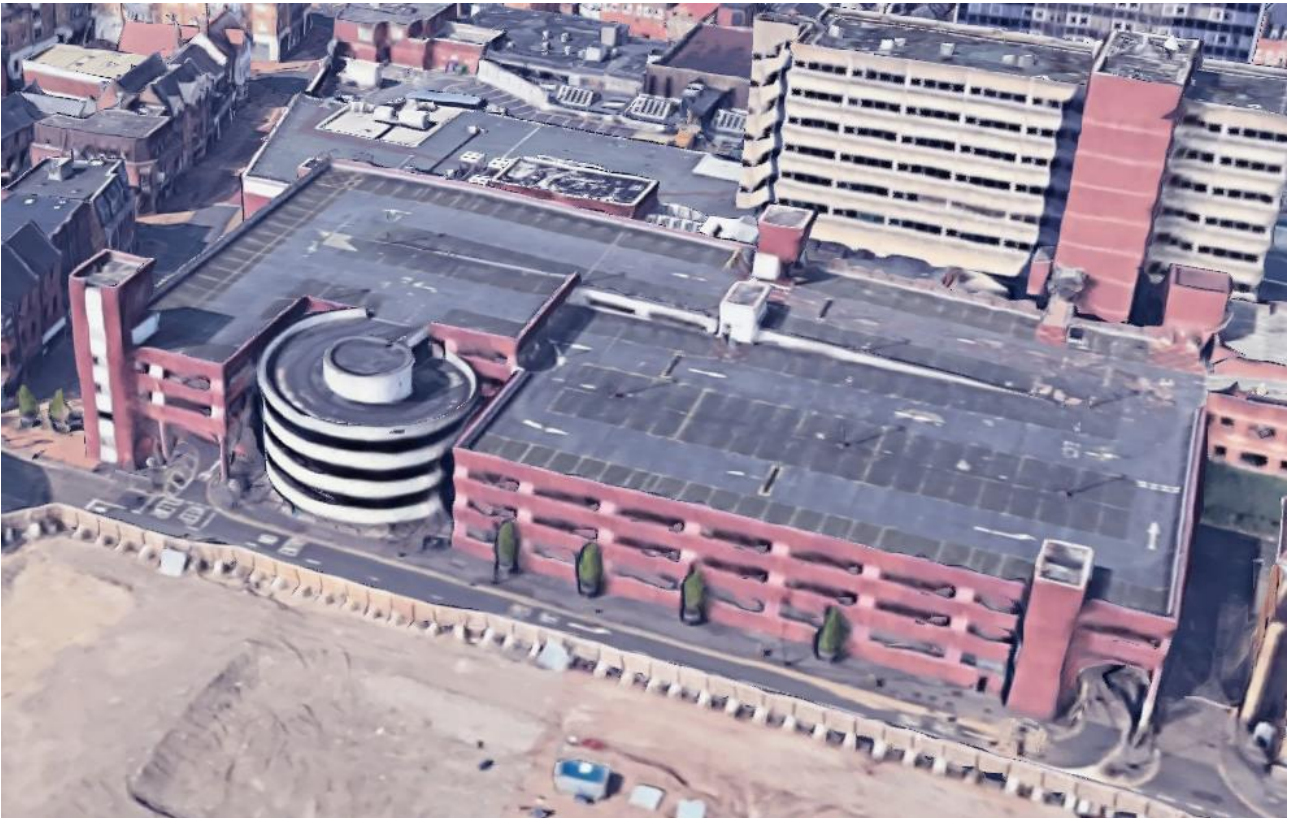
Fig. 1 – Aerial view of the site

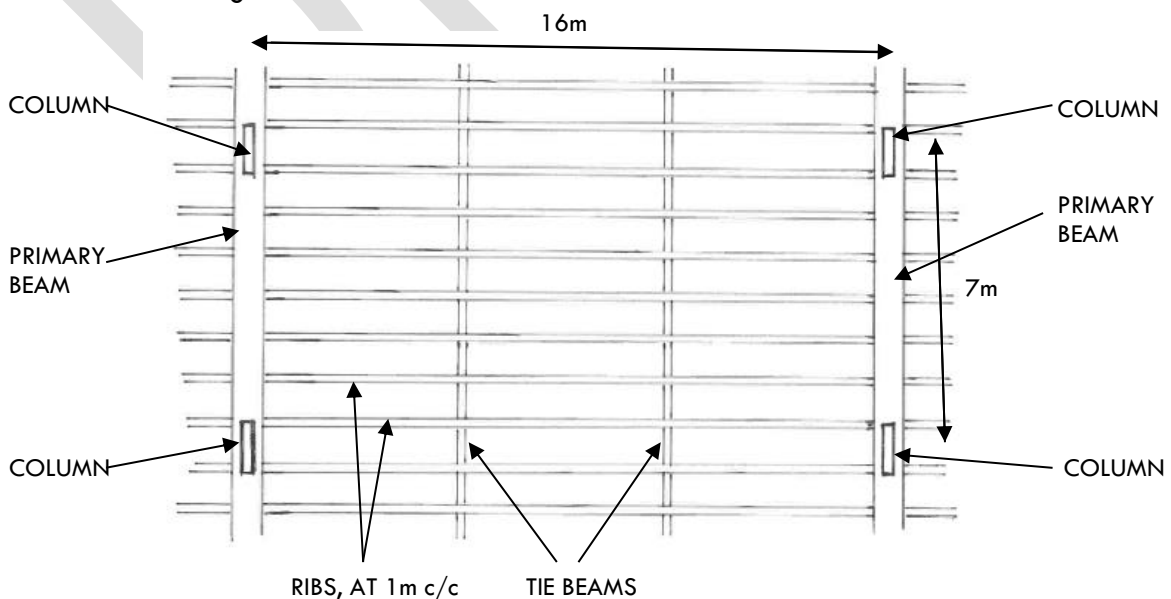
Fig. 4 – Typical 16m x 7m bay: Floor Structure

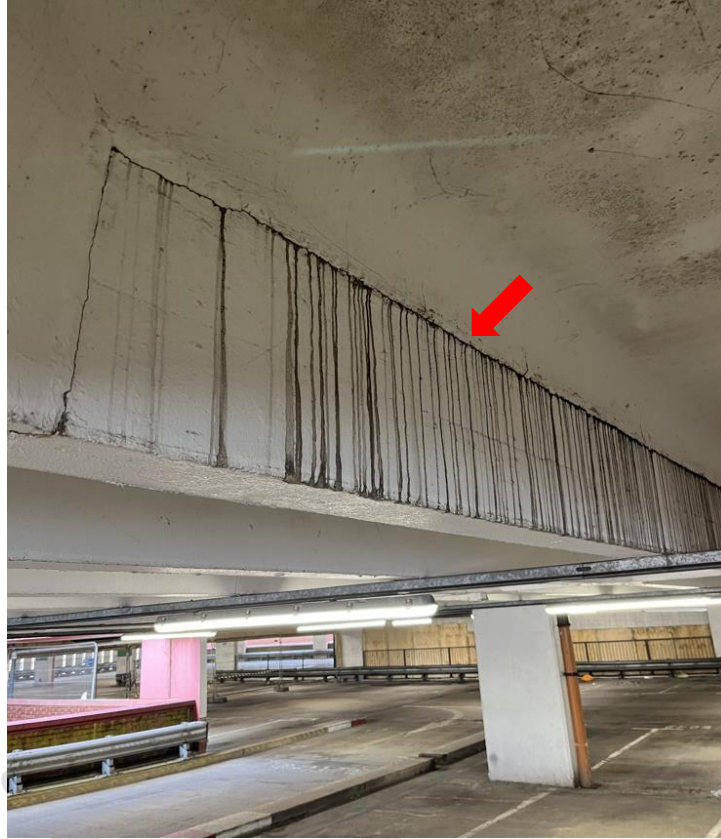
Fig. 5 – Typical crack at original construction joint, along top of rib

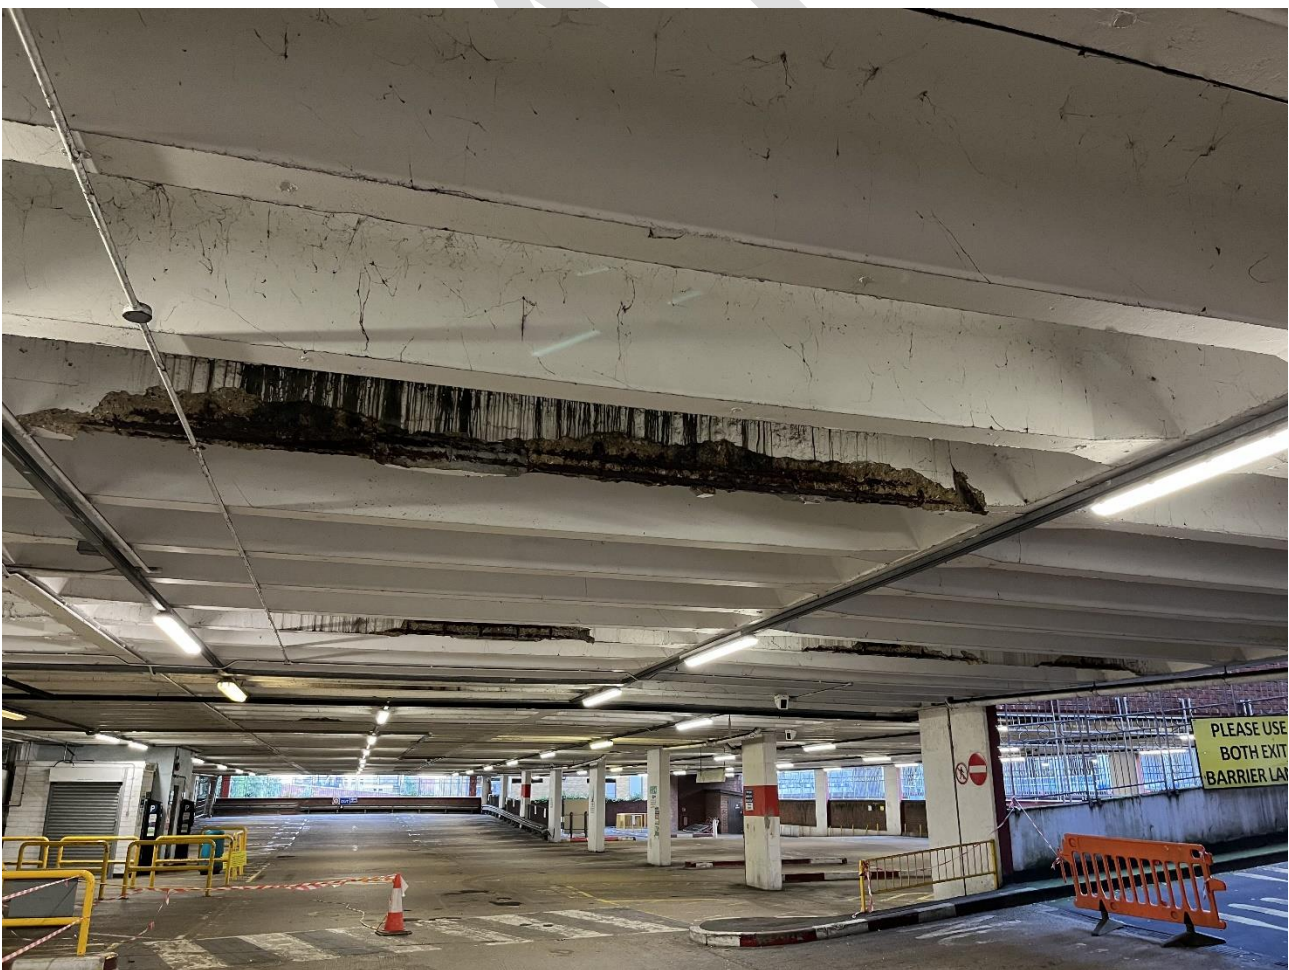
Fig. 7 – Spalled concrete ribs revealing corroded reinforcement

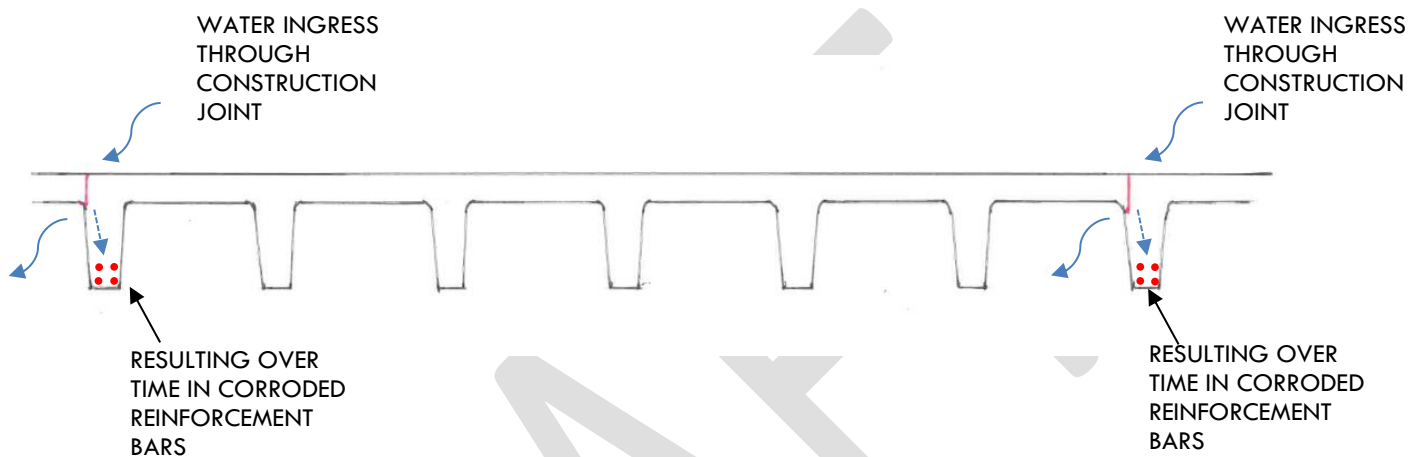
Fig. 8 – Typical section through floor slab: water ingress through construction joints (every 6<sup>th</sup> or 7<sup>th</sup> rib) with the potential to result in corrosion of the rib reinforcement

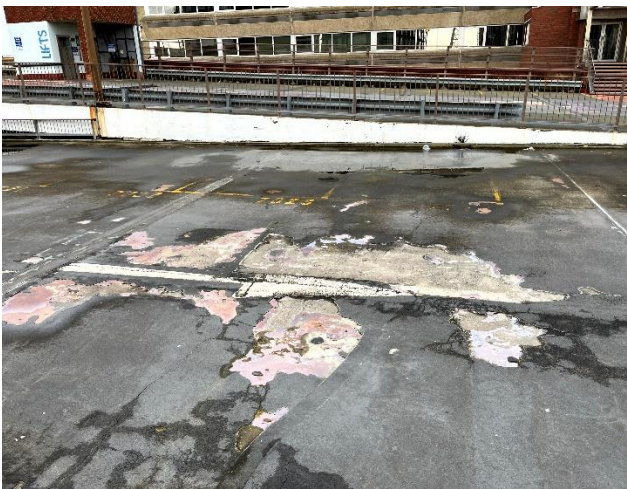
*Fig. 11 – Damaged waterproofing*

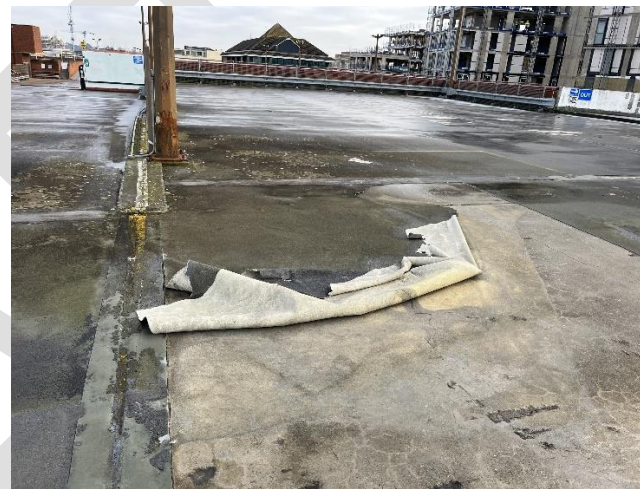
*Fig. 12 – Damaged waterproofing*

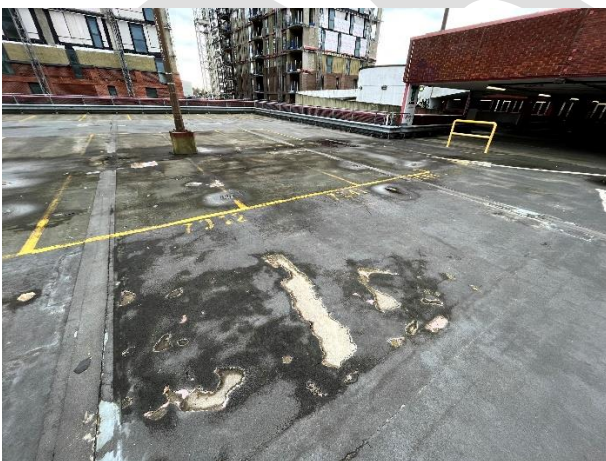
*Fig. 13 – Damaged waterproofing*

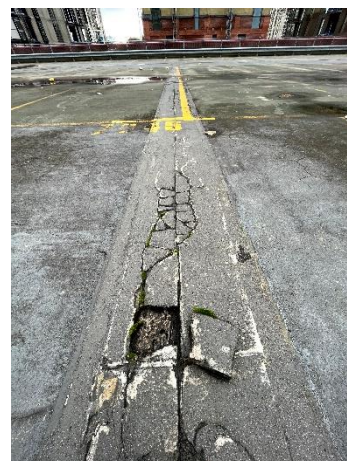
*Fig. 14 – Damaged seal over joint*
