BROADWAY CAR PARK,
MAIDENHEAD

STRUCTURAL VISUAL
INSPECTION

JANUARY 2023

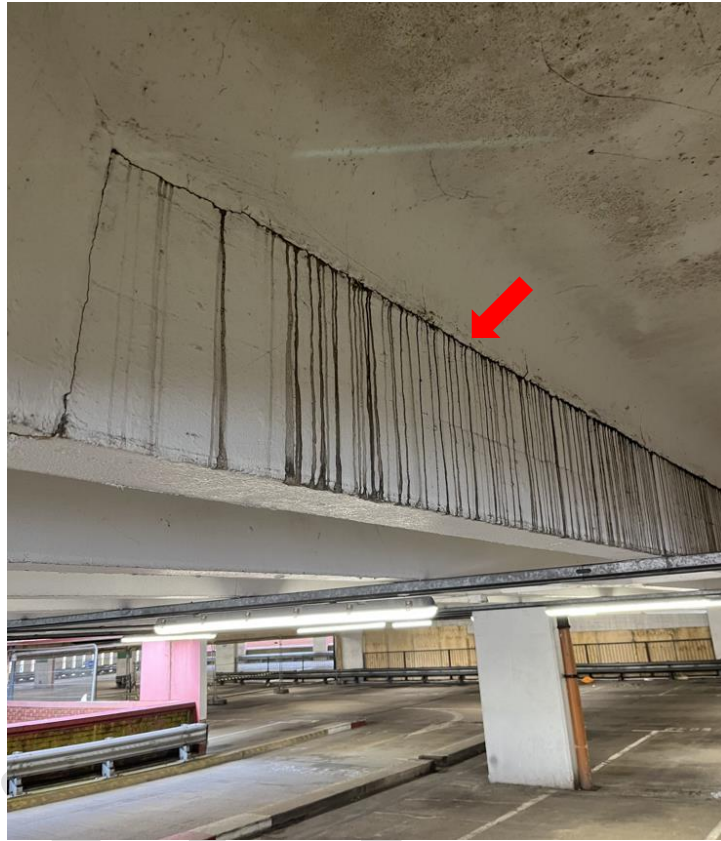
During the construction of this building it is likely that each concrete floor would have been poured sequentially in long strips across the building, in widths of 6m to 7m (each containing 6 or 7 ribs), separated by construction joints. These joints are visible throughout the building, and appear to have opened up gradually over time, likely due to water ingress, so that they currently appear as regular cracks at the top of every 6th or 7th rib. A lot of them have water stains making them clearly visible (Fig. 5). A typical bay layout showing these crack/joint locations is shown in Fig. 6 below.

Fig. 5 – Typical crack at original construction joint, along top of rib

- On all remaining ribs containing a construction joint (every 6th or 7th rib on all floors), and on all previous repairs, hammer test the rib
 - If concrete breaks off revealing corroded reinforcement, carry out the repair as outlined above

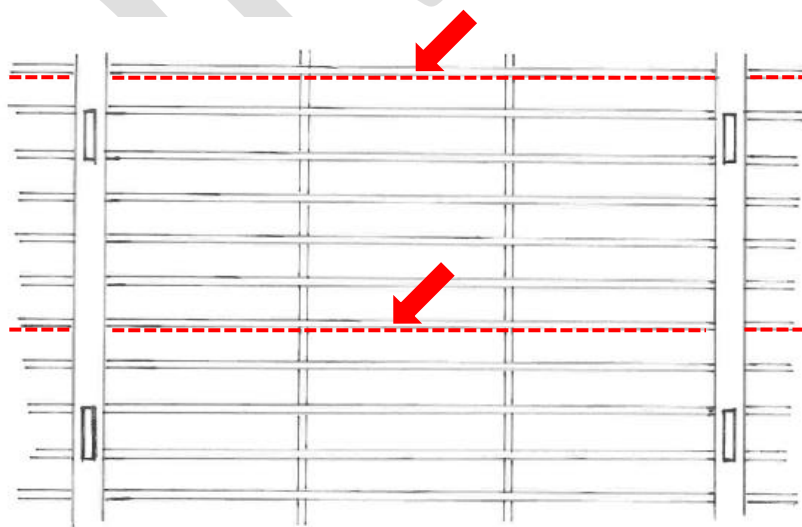
Fig. 6 – Typical 16m x 7m bay, showing typical crack at original construction joint, along top of rib

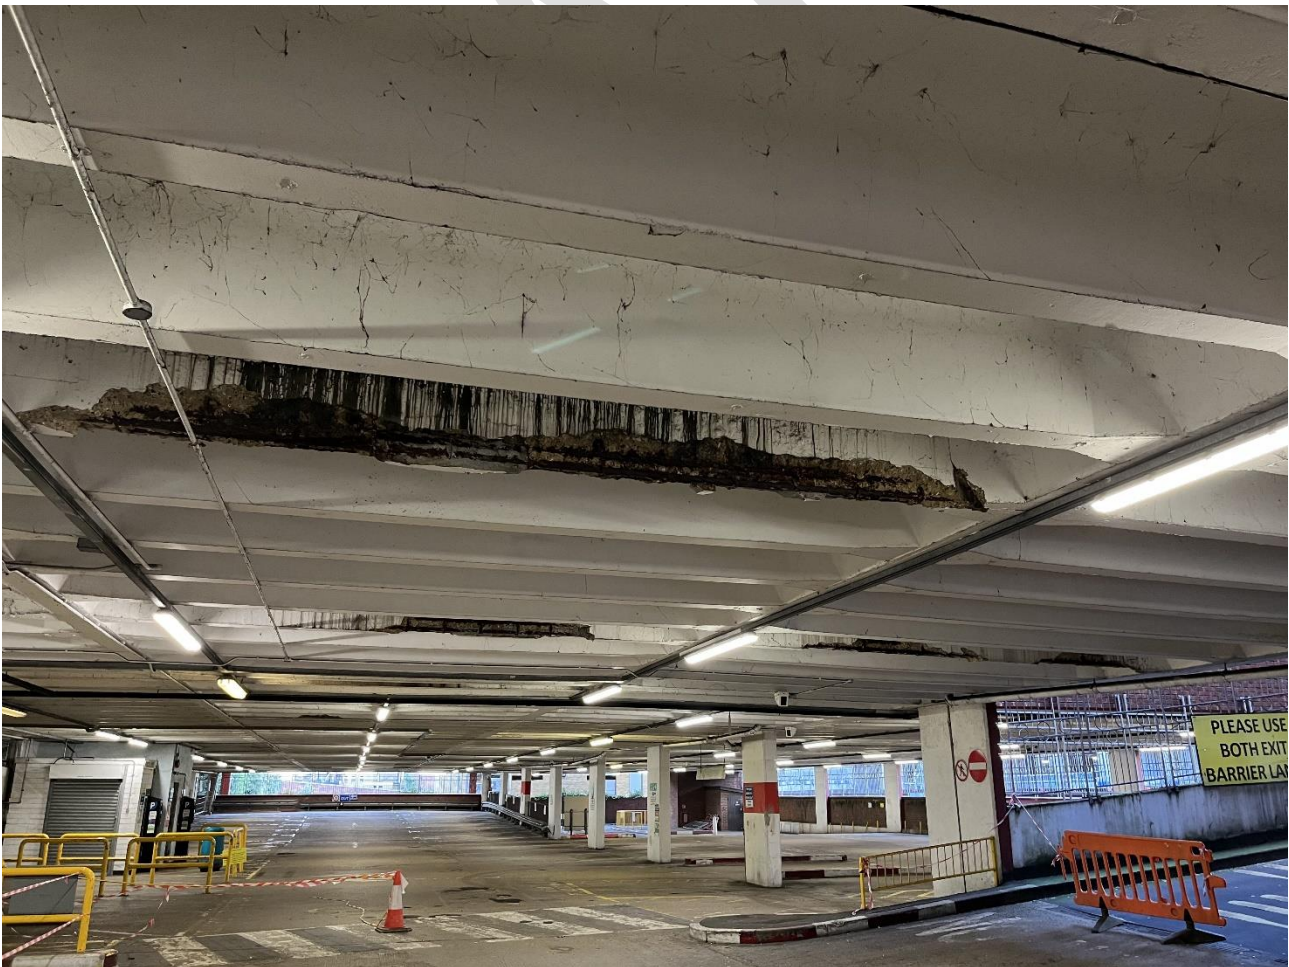
The main defects that prompted this report are several sections of spalled concrete that occurred on the underside of some of the First Floor ribs, close to the circular ramp area (Fig. 7). Fairly large sections of concrete have come off, revealing corroded reinforcement bars. This damage has occurred on ribs containing the cracked construction joint discussed above. Water staining is also clearly visible on these ribs.

Fig. 7 – Spalled concrete ribs revealing corroded reinforcement

Some of the material that remains around the corroded reinforcement appears to have a different composition to the rest of the concrete in the rib, suggesting this defect may have originally happened years ago and had already been subject to a repair using a particular kind of cementitious material. The exposed reinforcement bars are a twisted square type, commonly used in the 1960s, but no longer in use today. This just confirms the likely age of the building of at least 50 years.

The great majority of defects have occurred in the concrete floor ribs, caused by water finding its way through the original construction joints in the floors, which over time has caused the steel reinforcement bars in the ribs to corrode. As the bars have corroded they have expanded and exerted pressure on the surrounding concrete, eventually leading it to break off locally around the bars. All these defects need to be repaired. (For more details refer to the **Repair Schedule** below.)

- On all spalled ribs, remove any loose concrete around reinforcement bars and patch repair locally. This work would include:
 - Removing corrosion on bars by grit blasting or similar method
 - Applying proprietary primer coating to the bars
 - Depending on the size of the patch repair, inserting a length of new stainless steel bar alongside the existing
 - Applying a proprietary cementitious repair, e.g. Fosroc

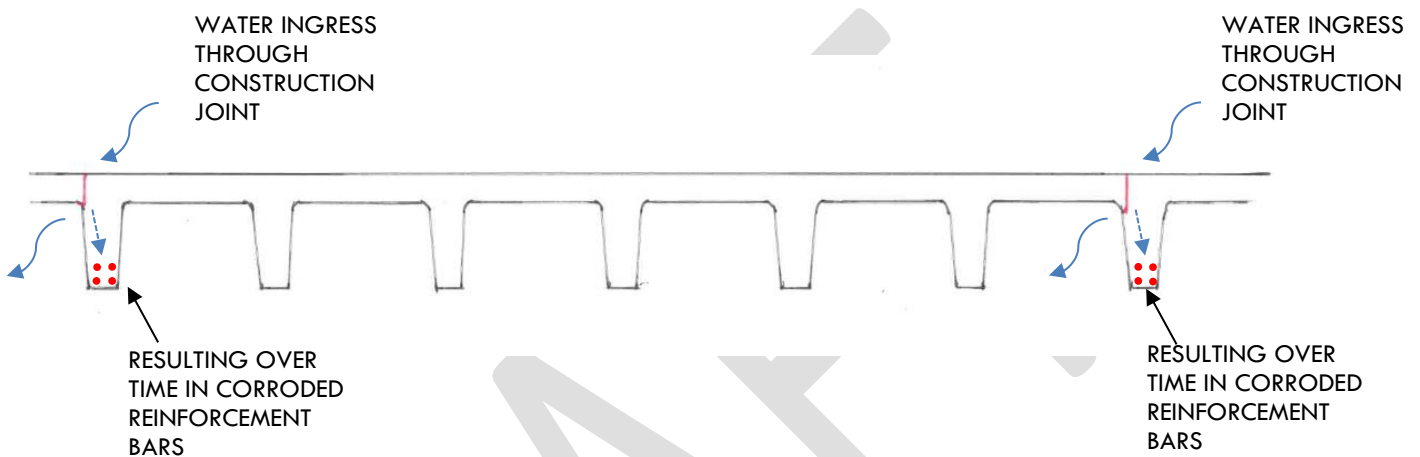
The inspection continued, floor by floor, across the rest of the building, where several more defects (and previously repaired defects) were observed. A clear pattern emerged in that the vast majority of these defects occur on the ribs containing the construction joint. It would appear that, where water can get through the joints it may over time also seep into the bottom of the rib itself, causing the reinforcement bars here to corrode.

Fig. 8 – Typical section through floor slab: water ingress through construction joints (every 6th or 7th rib) with the potential to result in corrosion of the rib reinforcement

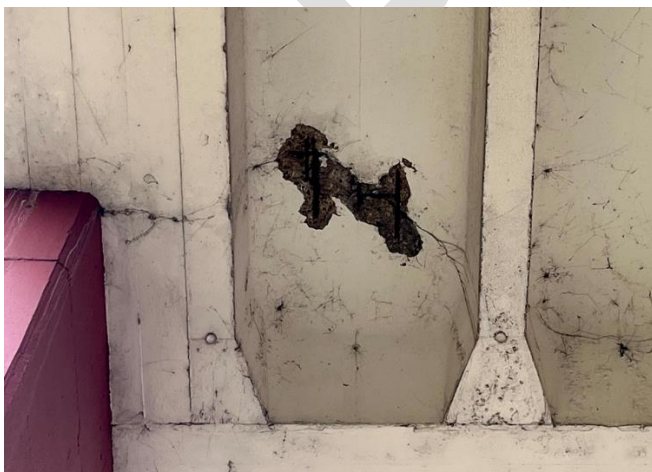
Some defects also appear as cracks to the underside of the short section of slab between ribs, either perpendicular or parallel to the ribs. These have probably been caused by other cracks in the top of the slab that have appeared over time, possibly through the repeated action of vehicles on the slab. This type of defect occurs much less often than the type on the ribs, and is limited to certain localised areas rather than throughout like the rib construction joint crack.

Fig. 9 – Transverse crack, slab underside

The second type of defect occurs to a much lesser extent and consists of cracks to the underside of the section of slab between ribs. These are either short transverse cracks perpendicular to the ribs, or longitudinal cracks parallel to the ribs. These cracks usually have rusty stains on them indicating that they are also caused by water ingress locally corroding bars within the slab. These should be hammer-tested and repaired locally where concrete breaks off revealing corroded reinforcement.

- Remove any loose concrete around reinforcement bars and patch repair locally. This work would include:
 - Removing corrosion on bars by grit blasting or similar method
 - Applying proprietary primer coating to the bars
 - Depending on the size of the patch repair, inserting a length of new stainless steel bar alongside the existing
 - Applying a proprietary cementitious repair, e.g. Fosroc

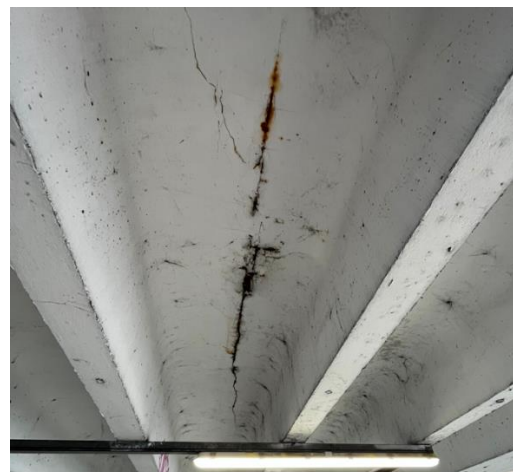
Fig. 10 – Longitudinal crack, slab underside

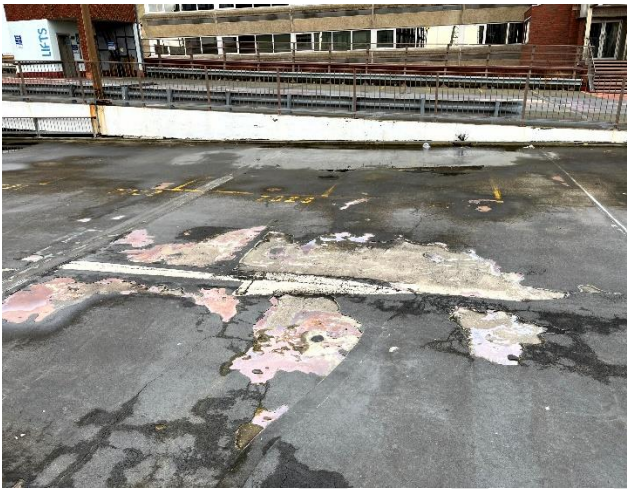
However large areas of the waterproofing are clearly damaged, which will result in water ingress. It appears this water ingress finds its way through the building to all floors below. While we were on site various areas of the floor underside were clearly wet, and even dripping wet.

Fig. 11 – Damaged waterproofing

- Repairing the defects mentioned above will provide a short-term structural solution. Since the concrete has been damaged by water ingress, a long-term solution would have to include applying new water-proofing to the top level of the car park.

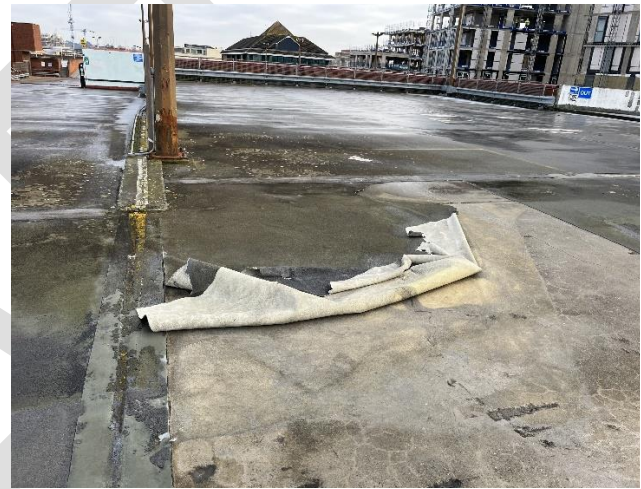
Fig. 12 – Damaged waterproofing

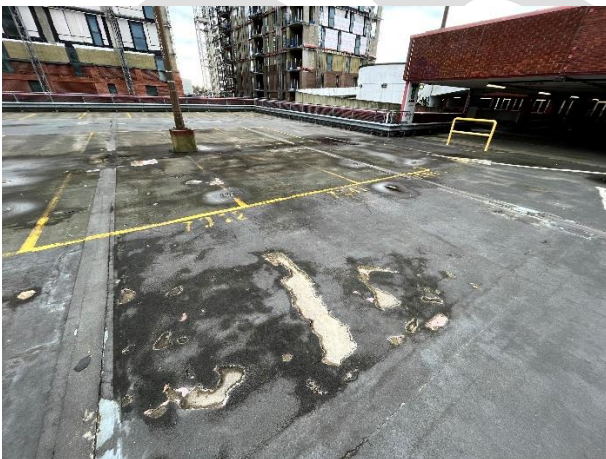
Fig. 13 – Damaged waterproofing

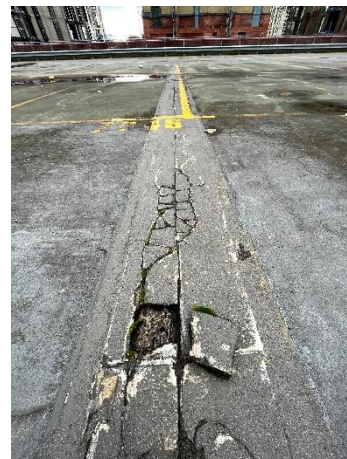
The top level, which is open to the elements, has had some kind of waterproofing membrane applied to the top surface of the concrete floor, and various joints in the concrete surface have been sealed with additional waterproofing.

Fig. 14 – Damaged seal over joint
