ITEM: A308 CYCLE ROUTE

1. Purpose of the Report

1.1 This report highlights issues associated with the shared footway / cycleway along the A308 between Maidenhead and Windsor and identifies options for addressing them.

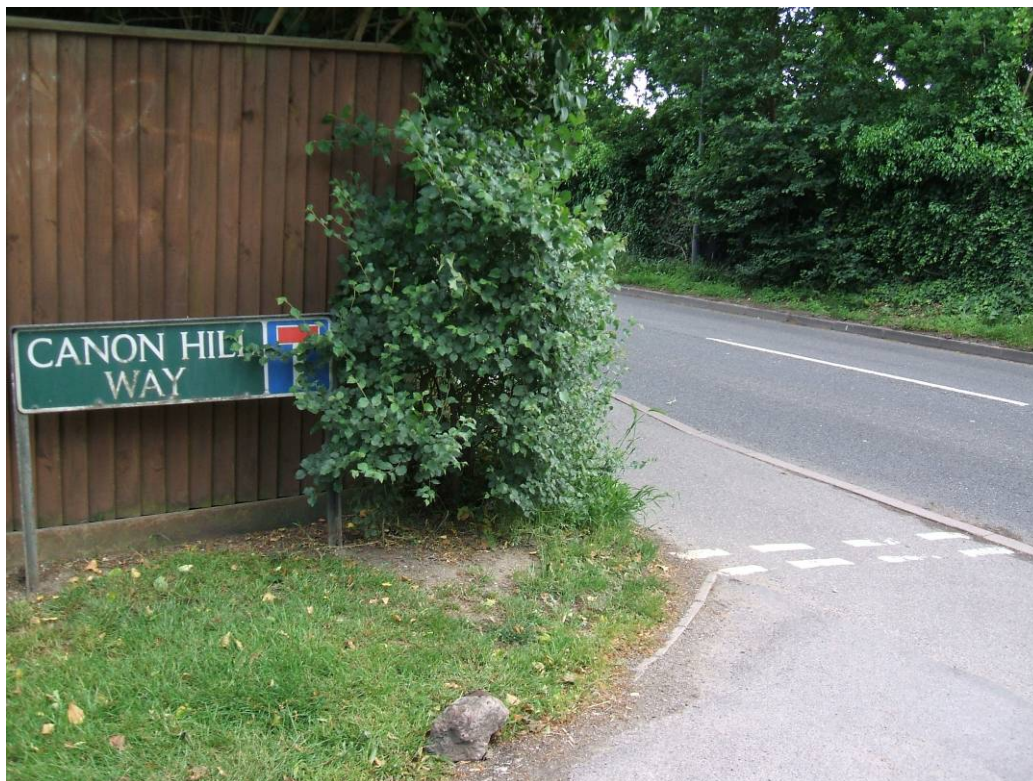
Figure 1: Junction of A308 / Canon Hill Way

- 2.6 Recently, there have been two incidents reported to the council where cyclists have been involved in collisions at the junction of the A308 cycle route and Canon Hill Drive. This junction has particularly poor visibility between motorists emerging from the side

road and users of the footway / cycleway. Markings have been put on the footway / cycleway to indicate that cyclists should give way to vehicles turning in and out of the side road, but these do not appear to be effective in tackling the problem.

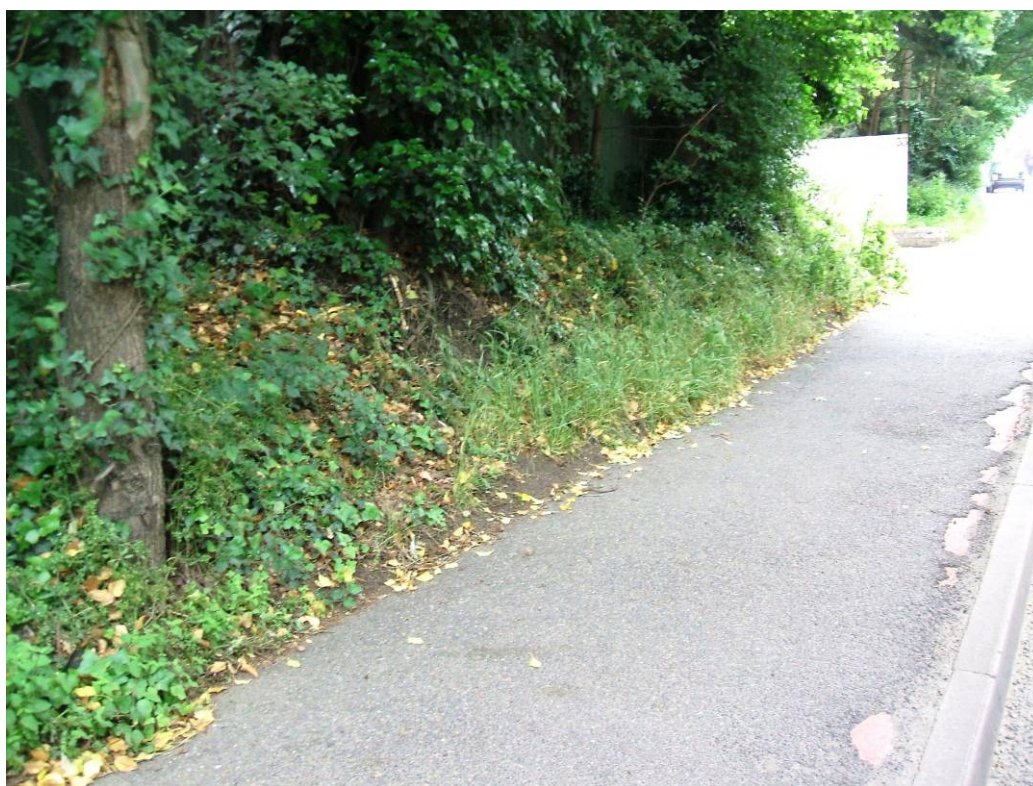
Figure 2: Highway Verge to Rear of Footway / Cycleway

- 2.10 It should be noted that the highway land to the rear of the footway / cycleway contains a number of mature trees, hedges and other vegetation, which screen properties from the road. Widespread removal of the trees would be likely to meet with opposition from residents due to the loss of screening and the adverse impact on the character of the road.

- 2.11 It should also be noted that the land rises steeply with boundaries of some adjacent properties being 700mm or more above the level of the footway / cycleway. Utilising this land would therefore require retaining walls, which are very costly to construct. These works could potentially damage trees that are close to residential property boundaries. Some of these are covered by Tree Preservation Orders, particularly those near Braywick Roundabout and Upper Bray Road.

- 2.8 **Option 1: Widening** - According to LTN 2/08: Cycle Infrastructure Design, the desired width for an unsegregated shared footway / cycleway adjacent to the carriageway on one side and a fence at the other is 4m. This allows for a 3m wide path with a 0.5m buffer on either side.

- 2.9 The current footway / cycleway between Braywick Roundabout and Upper Bray Road is typically 1.6m wide. There is highway land to the rear of the footway, which would allow the path to be widened. A facility of 3m would be achievable through most of this section, although at some locations the path would be narrower, reflecting the varied line of the highway boundary. Even at 3m, this is significantly below the recommended standard, but would at least be an improvement on current conditions.

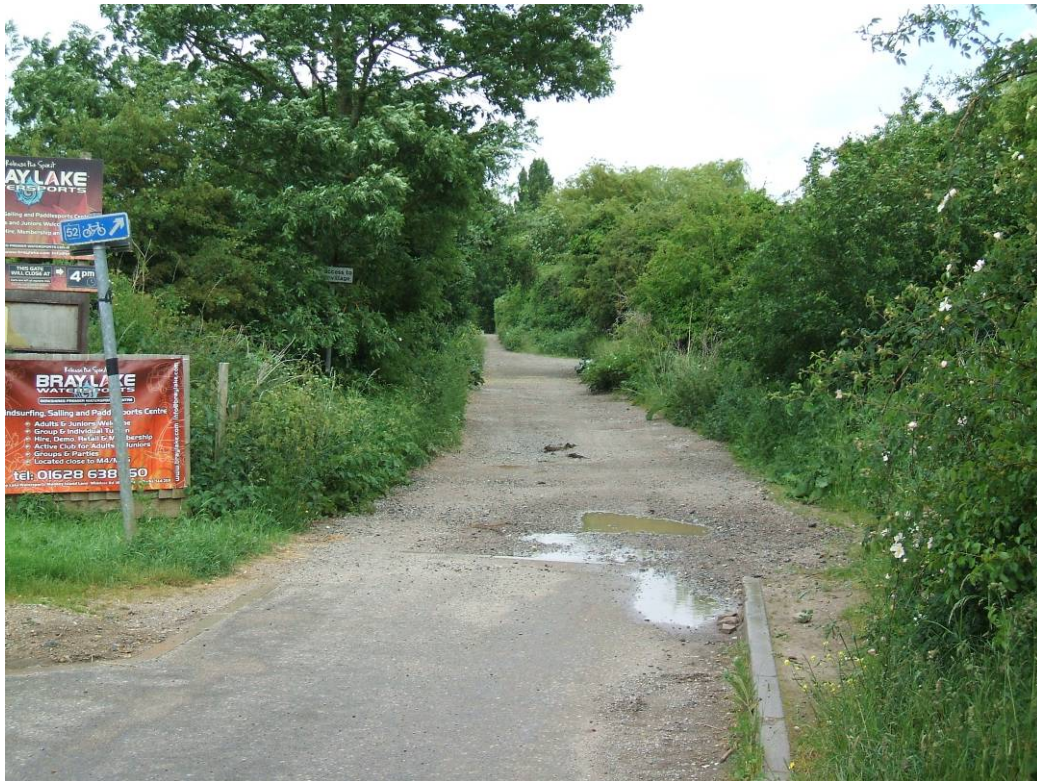
Figure 3: Monkey Island Lane (Public Bridleway)

- 2.13 However, a route could be achieved that would make use of the existing A308 footway/ cycleway between Windsor and Fifield before diverting down Monkey Island Lane. This is a public bridleway between Tithe Barn Drive and the Monkey Island Hotel access road. Although this section is currently unsurfaced, it is about to undergo improvement works and could be made up to a standard appropriate for cycling with little difficulty. Beyond the hotel access, the road is adopted with an asphalt surface. Monkey Island Lane is very lightly trafficked and does not require any dedicated cycle provision.

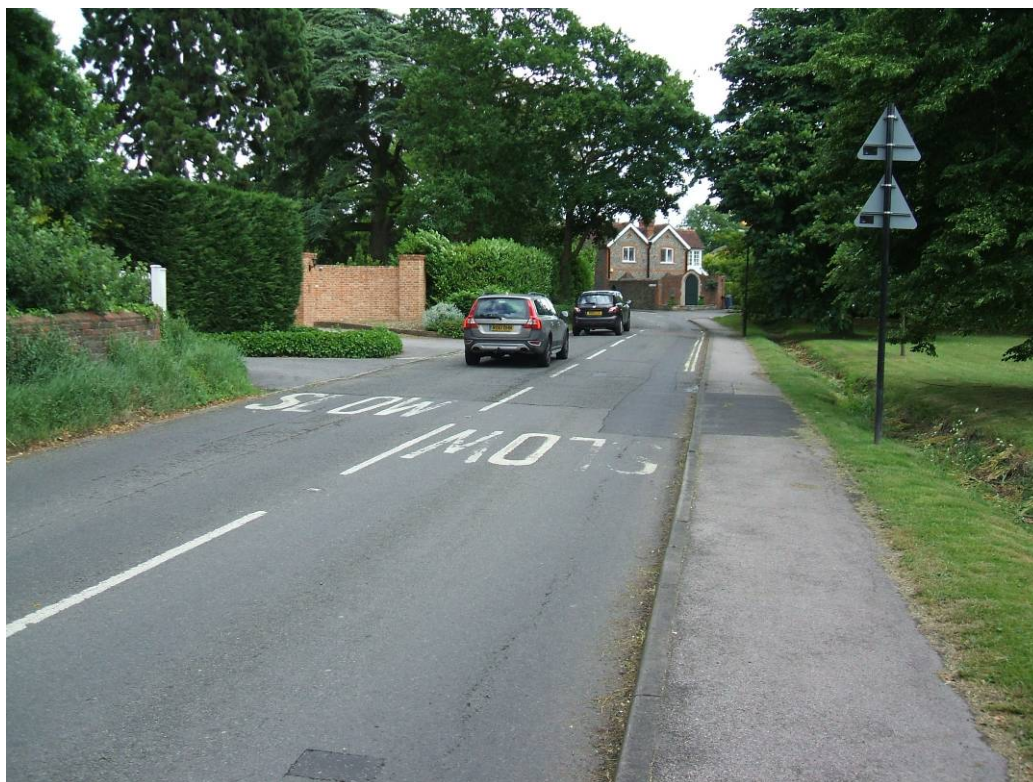
Figure 5: B3028 Bray Road

- 2.15 Bray Village does not currently have any dedicated cycle facilities except for a cycle exemption at the no-entry restriction between Ferry Road and Old Mill Lane. Although Bray Road is a B-road, a 20 mph speed limit is in force throughout the village.

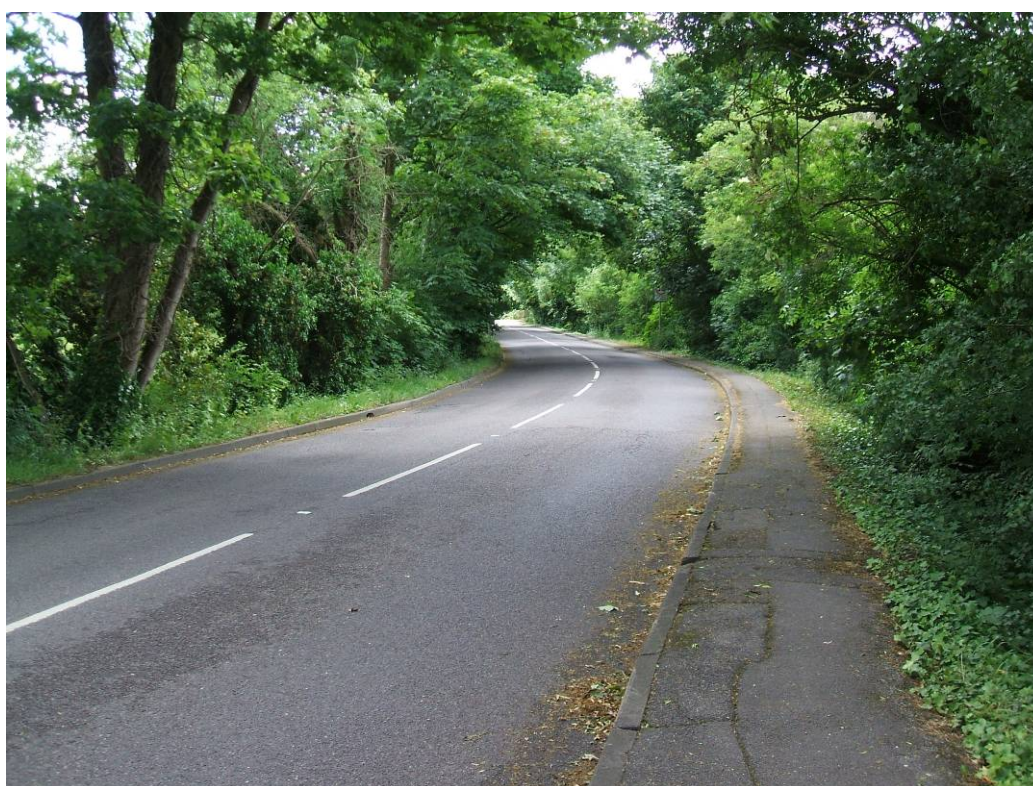
Figure 6: Hibbert Road

- 2.16 Hibbert Road is subject to a 30 mph speed limit and does not have any dedicated cycling infrastructure. It is not currently wide enough for on-carriageway cycle lanes alongside the existing traffic lanes. Although there is highway land available for widening, this would involve extensive clearance of trees and vegetation, which would significantly change the character of the road and would require extensive drainage works. Also, a continuous facility could not be achieved, since the extent of the highway land is constrained by property boundaries around Winbury School.

- 2.17 Given the relatively low traffic speeds and flows, advisory cycle lanes with a single lane for vehicles could be appropriate for this location. This approach is used extensively in the Netherlands and is covered in more detail in the report on Cycle Routes to Charters School.
