# CABINET

<u>ITEM</u>	SUBJECT	PAGE NO
	v. Draft Conservation Area Appraisal: Maidenhead Town Centre	3 - 68

**1.1** The Borough Council has carried out an appraisal for the Maidenhead Town Centre Conservation Area and produced this appraisal document, which describes the important features and characteristics of the area and will be used when planning decisions are made that affect the area. The approach used follows advice set out in Historic England guidance.

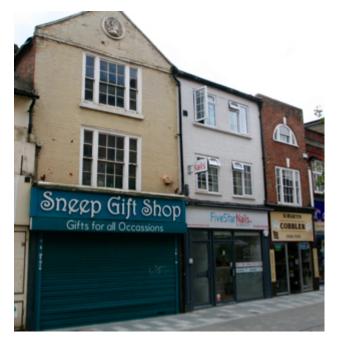
**6.2** No early buildings seem to be visible from the High Street, but that is not to say that they do not exist. 95 to 99 High Street, for example, preserve a frontage reflecting their medieval plot size and perhaps remnants of earlier buildings behind eighteenth-century façades. The remains of a timber framed structure exist within number 126. The early nineteenth-century façade of 81 High Street disguises what is probably a timber-famed building with a narrow passage that led to a garden or court behind. A rear view of 104 High Street reveals the remains of a queen strut roof behind an unremarkable retail façade, suggesting that a detailed inspection may be warranted.

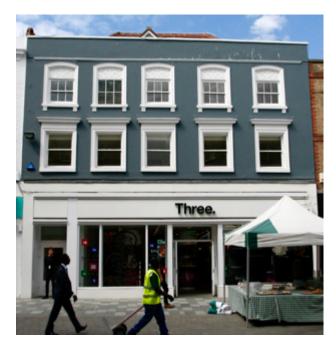
**6.6** The development of Queen Street, laid out in 1872 to connect the High Street to the new railway station, is characterised by large terraced developments with small shops on the ground floor. The grandest is 7 - 21 Queen Street built of London stock brick, with sash windows and stone dressings; the central block has classical pilasters and an attic storey. Number 7 preserves its original shop front, with curved corner window, and mosaic floor. The effect is unfortunately compromised by the intrusive security shutter. On the smaller plots available on the High Street a number of three storey buildings were inserted with shops below and accommodation above. Number 21 displays fine polychrome brickwork and a cornice with classical detailing. The superficially similar 76-78 High Street appears to be one of many examples of Victorian re-facing of an earlier building.

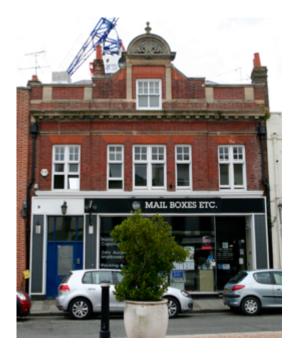
**6.7** There are many interesting buildings dating from the turn of the twentieth century. Number 5 High Street, brick with stone dressings, gives a nod in the direction of Queen Anne. The Tudor Revival Post Office combines bricks, ceramics and stone dressings with complex gables and roofs. A more eclectic approach is adopted at number 29 with bulbous columns, oversized scrolls and green glazed tiles. Arts and Craft architecture is represented by St Mary's church hall and the shop at 124 High Street.

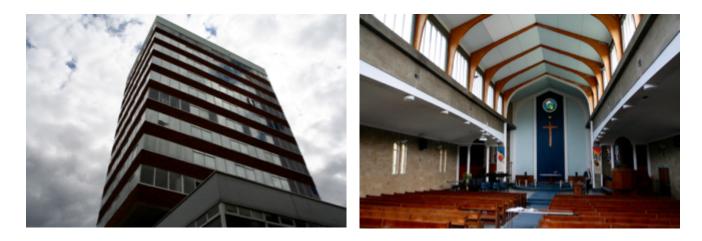
**6.9** The relief road fundamentally changed the character of the High Street. Reinforced concrete and glass became an important building material. The 1960s pedestrianised Nicholsons Shopping centre and the high rise office development at Berkshire House typified the new types of buildings in new materials. The recessed concrete deck apartments, above shops at 21-32 High Street, reflect the architecture of Patrick Hodgkin's Brunswick Square flats in London. Also of the 1960s is St Mary's church where the clerestory is supported on a pair of long span concrete beams. Incremental insertions into the High Street for banks and shops often have brick facades in a, usually unsuccessful, attempt to harmonise with older buildings.

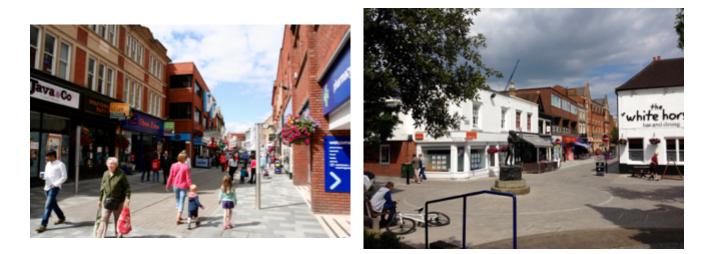
**7.2** The pedestrianisation of the west end of the High Street provides a traffic free environment that serves as a valuable open space in the town centre. This area is used at the end of the week (Thursday, Friday and Saturday) for a small number of market stalls. The space is enclosed by the line of buildings flanking the street. There are no substantial gaps between buildings so that the only view out of the space is towards the Castle Hill roundabout at the west end of the High Street. Here a small public open space has been created in front of The White Horse and the Methodist Church, with a sculpture of a boy with a model boat by Lydia Karpinska at its centre.

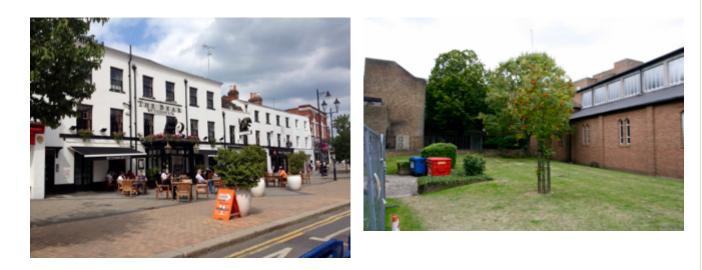
**7.7** The area in front of The Bear at the Chapel Arches provides the principal open space. This will be even more spacious once the temporary builders' hoardings have been removed revealing a view of York Stream. Most of the retail here is provided by small shops in The Colonnade. Tables and chairs outside The Bear create a relaxed outdoor environment for customers.

**7.8** The pavement is edged with stone kerbs. Pavement surfaces are confused and of low quality. Concrete paving bricks predominate in at least three different colours in combination with concrete paving slabs. There are some granite sets and York stone paving in front of The Bear. Street furniture is equally confused and of mixed quality including: black neo-Victorian lamp posts, black utilitarian bollards, polished steel cycle stands, glazed civic information boards, large white planters and a mixture of litter bins.

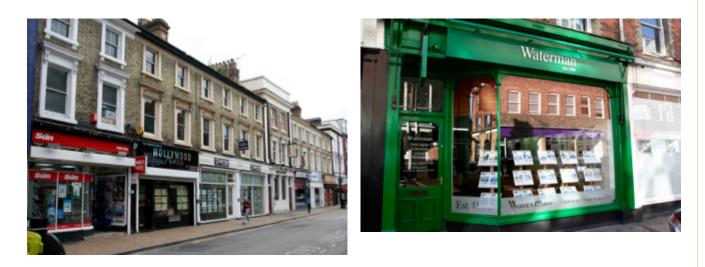
**7.17** Queen Street is a formally laid out street dominated by two late-nineteenth-century terraces of shops with accommodation over. On the east side (7-21) the terrace is built of yellow stock brick. It has a central block with pillasters, and attic storey. Originally, there were similar blocks at each end, but the left hand block was lost with the building of Berkshire House. Shop fronts are of mixed quality, with one (No 7) preserving most of its original features. The terrace on the west side (14-40) is less monumental. It is built of red brick with slate roofs. Close inspection reveals variation in details along the length of the terrace, for example decorative brickwork, string courses and details of lintels over the windows. This suggests that the terrace was built in a series of stages or by different builders. Some good shop fronts are preserved including entrance paving and door furniture (see No 20). Both terraces have sash windows the majority of which are preserved, though some uPVC replacements are reducing the integrity of the terraces. Some windows are in poor condition.

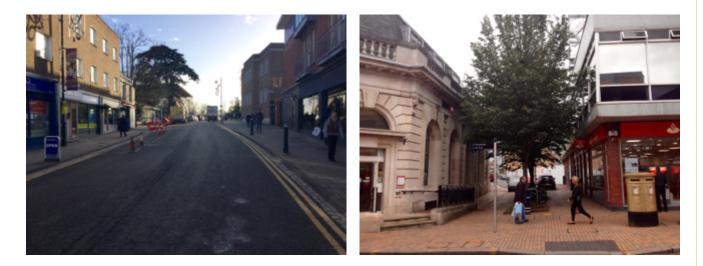
**7.21** The gentle meandering of the High Street results in views terminated by buildings. Of these the most distinguished is the view west towards the buildings on the corner with Queen Street featuring the diagonally set door of the Lloyds Bank and the copper roof of the turret room of No 47. There are also a number of views up small streets and alleyways such as the view towards St Mary's Church and up Old Post Office Lane.

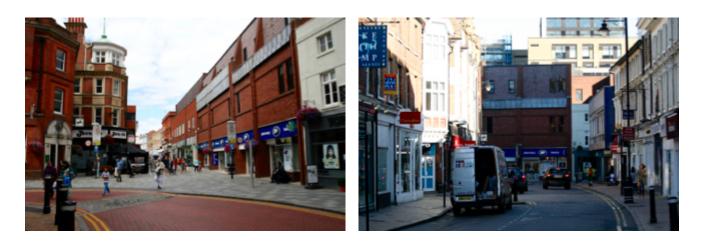
**7.22** There are several locations where potential views result in disappointment. The view down Market Street which would formerly have terminated with the Guild Hall now frames the tower of Berkshire House. The view down Queen Street terminates with the bland brick facade of Boots Chemist.

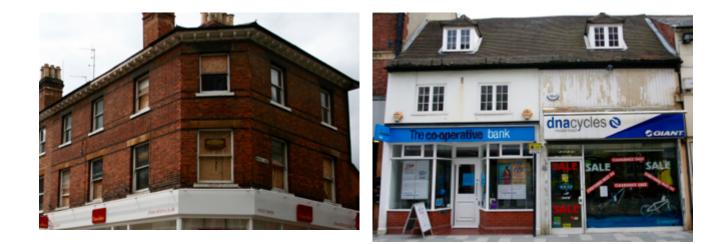
**8.1** The condition of buildings in the conservation area is very mixed. Some buildings have been well maintained, shopfronts improved and original features retained and celebrated. Others are in a seriously dilapidated state and are badly in need of maintenance. Others continue to suffer the loss of historic fabric, typically through replacement uPVC windows or inappropriate shop fronts and signs.
