The Wraysbury Drain – an ‘ordinary watercourse’?

A brief report to Wraysbury Parish Council from Ewan Larcombe 9/10/2019

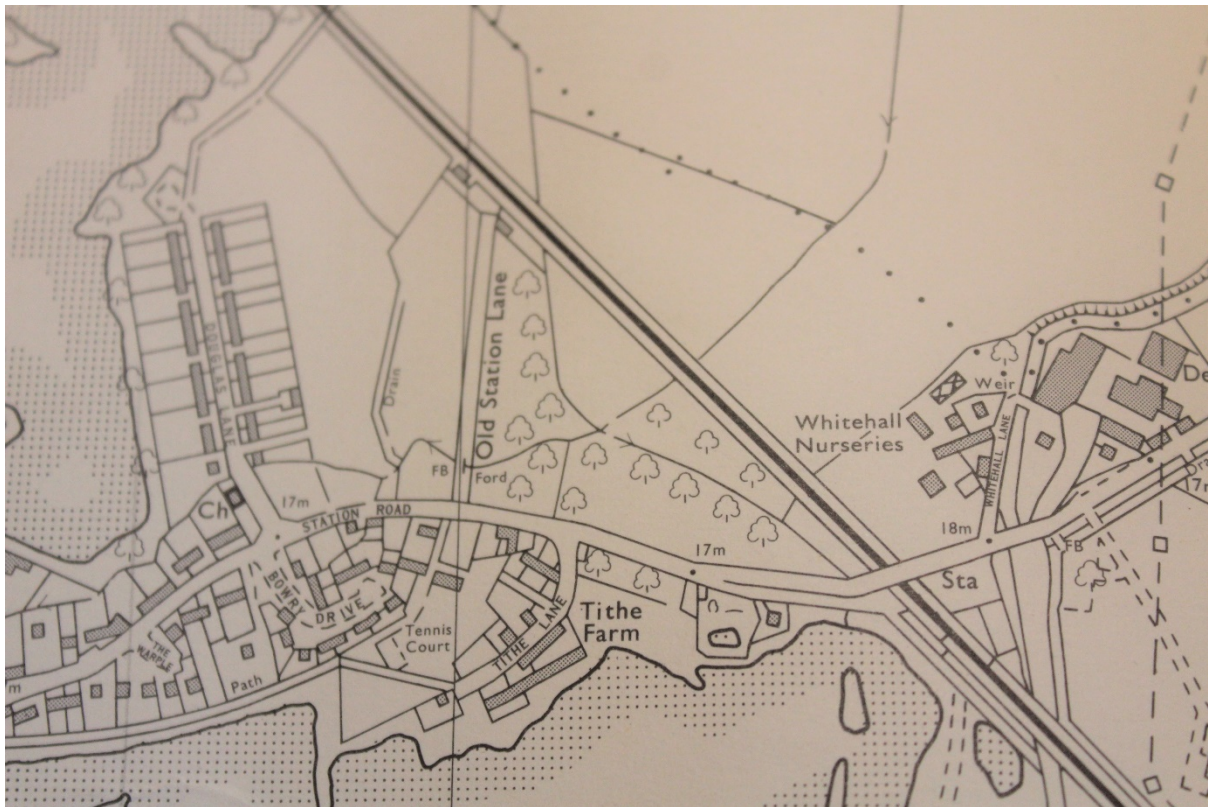
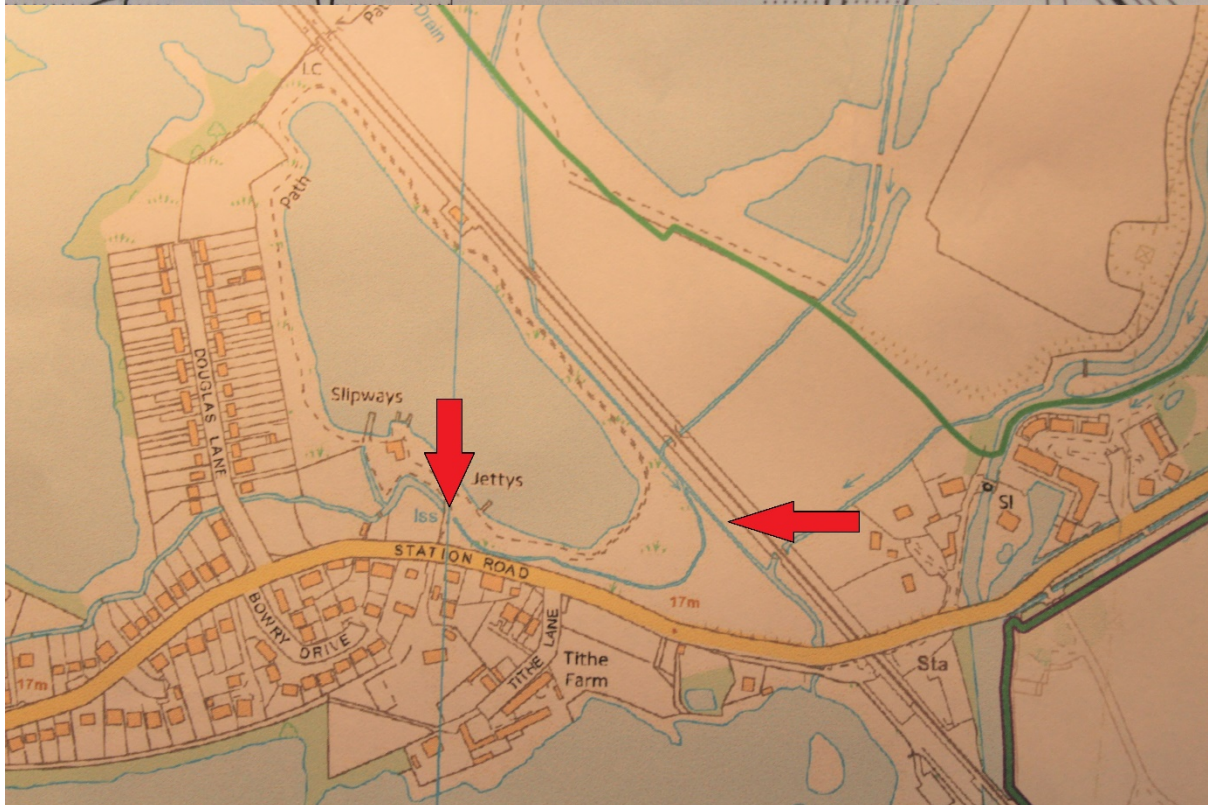
Maps: Wraysbury Drain at Station Road, Wraysbury.

The two images below show the Wraysbury Drain route both ‘before and after’ 1988. The two red arrows on the lower image indicate the positions of the current Dive Centre restrictions and the Wraysbury Station Weir. In my opinion **the channel between the two arrows (about 250m) requires re-engineering in terms of channel width/depth and gradient. This is a major project.**
