BROADWAY CAR PARK,
MAIDENHEAD

STRUCTURAL VISUAL
INSPECTION

JANUARY 2023

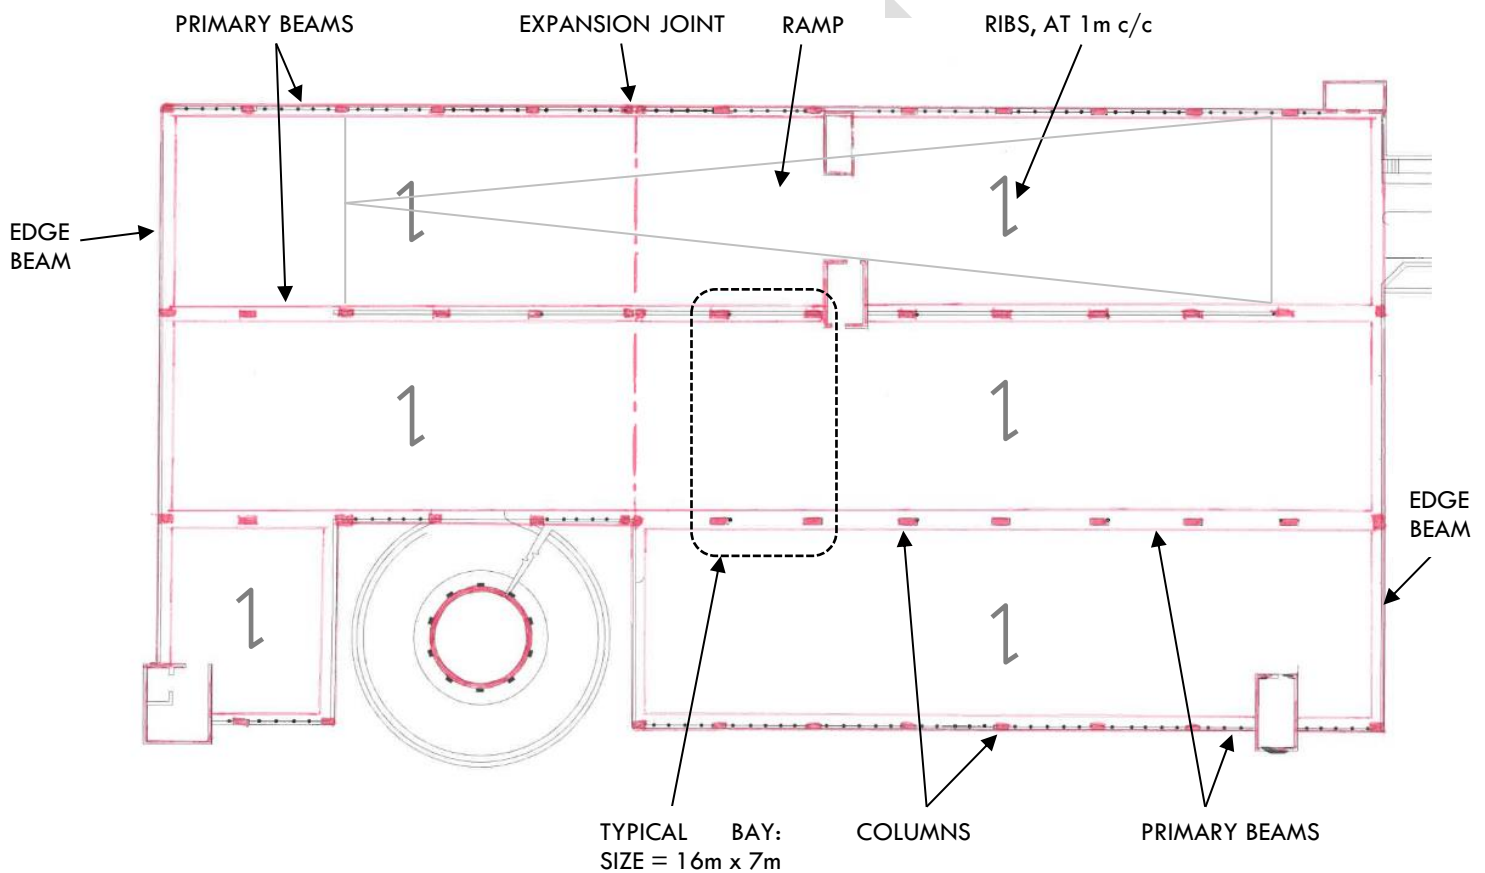
Fig. 2 – Typical Floor Plan

An expansion joint that runs north/south across the whole width of the building is clearly visible on each floor level. It is located directly to one side of the circular ramp and effectively divides the building into two structures. This is not unusual for a building of this size and would have been provided to allow for thermal expansion and contraction without damaging the structure.

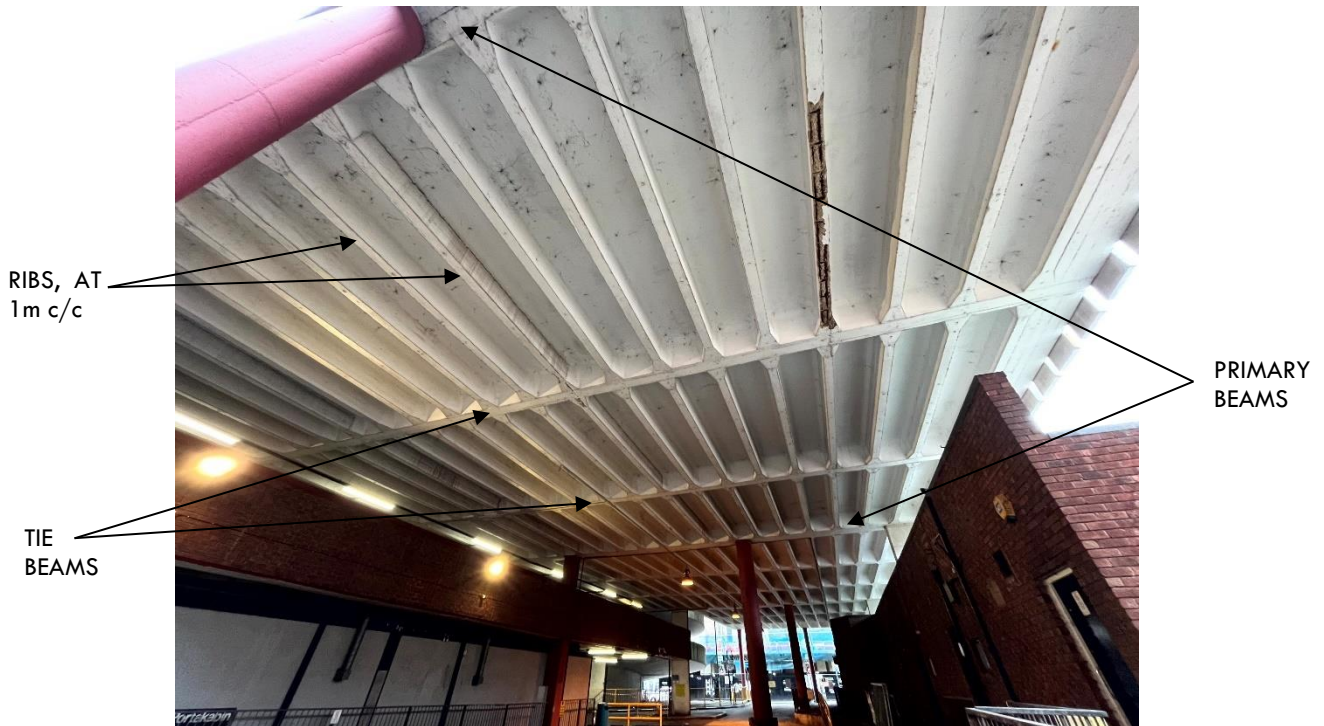
Fig. 3 – View of Typical Floor Structure

The undersides of the main reinforced concrete structural elements are generally all visible from each floor level throughout the building (Fig. 3).

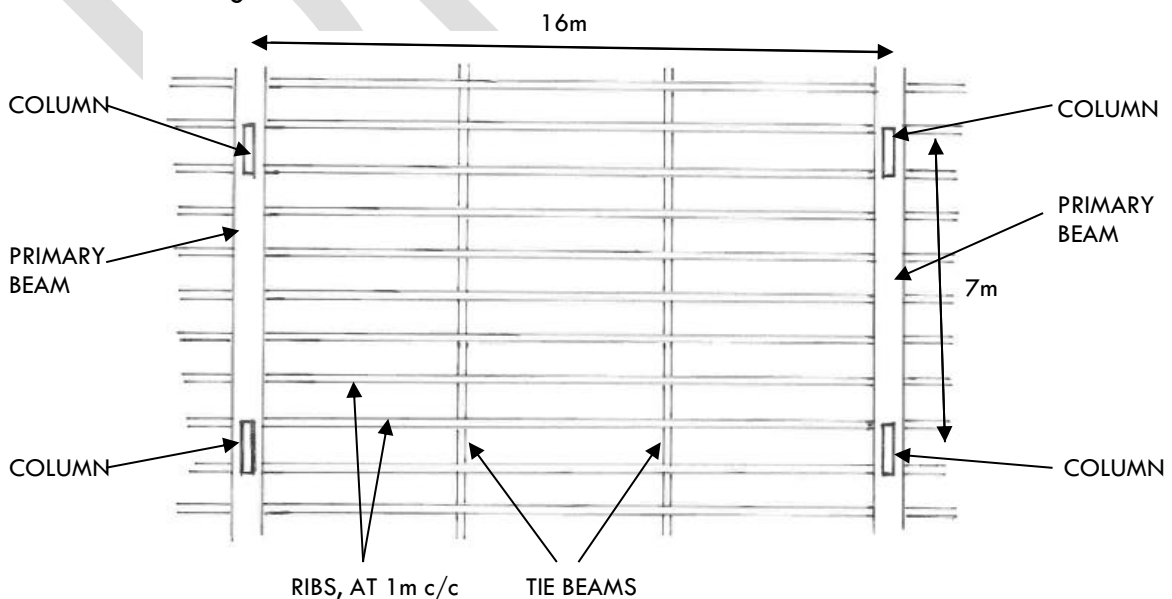
Fig. 4 – Typical 16m x 7m bay: Floor Structure

Each floor is divided into a regular series of bays about 16m x 7m, with 1200mm x 300mm (or, in some locations, round) concrete columns in each corner of the bay. Primary concrete beams run around the building perimeter and also internally in an east-west direction, aligned with the columns. A series of ribs (500mm high x 150mm wide at 1m c/c) span the 16m bay distance in a north-south direction between the primary beams. 2 No. tie beams per bay run perpendicular to the ribs. A typical bay layout can be seen in Fig. 4.
