1.1 The Borough Council has carried out an appraisal for the Maidenhead Town Centre Conservation Area and produced this appraisal document, which describes the important features and characteristics of the area and will be used when planning decisions are made that affect the area. The approach used follows advice set out in Historic England guidance.

Conservation Area Appraisal

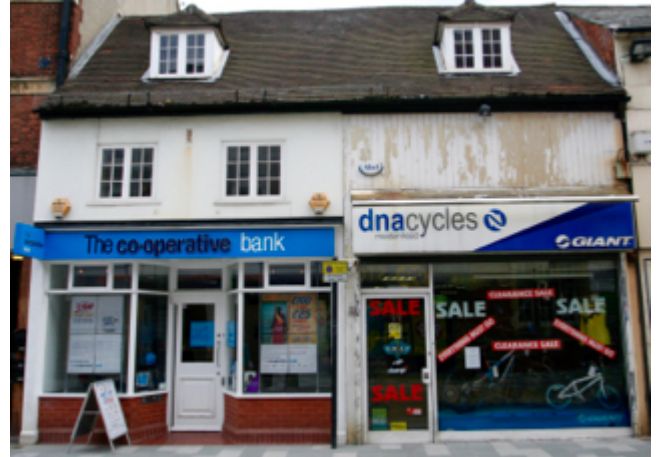
8.1 The condition of buildings in the conservation area is very mixed. Some buildings have been well maintained, shopfronts improved and original features retained and celebrated. Others are in a seriously dilapidated state and are badly in need of maintenance. Others continue to suffer the loss of historic fabric, typically through replacement uPVC windows or inappropriate shop fronts and signs.
