1.1 The Borough Council has carried out an appraisal for the Maidenhead Town Centre Conservation Area and produced this appraisal document, which describes the important features and characteristics of the area and will be used when planning decisions are made that affect the area. The approach used follows advice set out in Historic England guidance.

1.2 This is a revised appraisal document produced for Maidenhead Town Centre and is part of a longer-term project to review all the existing Conservation Area Appraisals in the Borough, and to complete appraisals for Conservation Areas that do not presently have one.

Conservation Area Appraisal

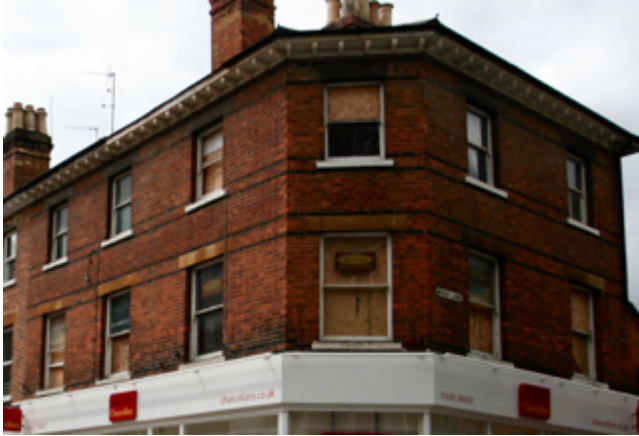
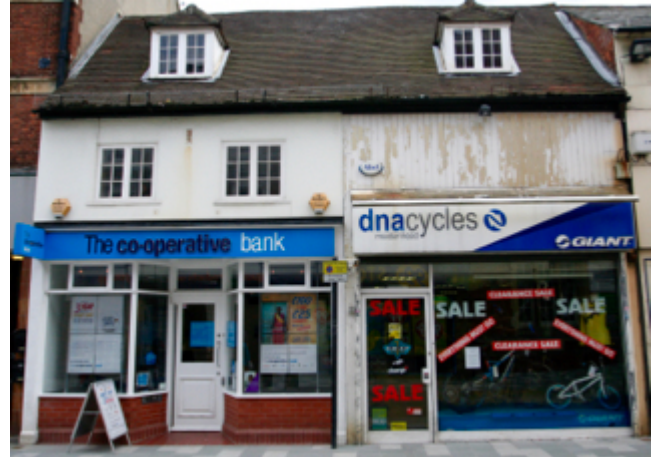
8.1 The condition of buildings in the conservation area is very mixed. Some buildings have been well maintained, shopfronts improved and original features retained and celebrated. Others are in a seriously dilapidated state and are badly in need of maintenance. Others continue to suffer the loss of historic fabric, typically through replacement uPVC windows or inappropriate shop fronts and signs.

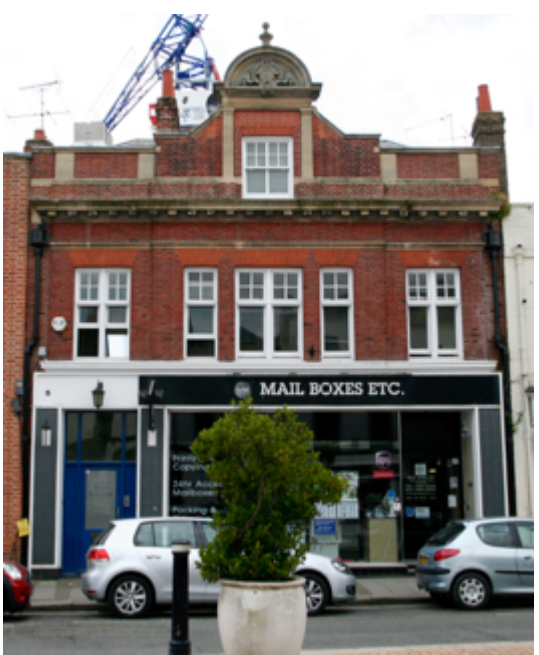
7-9	<p>Mid-nineteenth-century shops with accommodation over. Painted brick, number 9 retains more original features. Note arched door which was originally matched by a similar door in number 7. Number 9 also retains sash windows and lacks the modern skylights in the roof.</p>

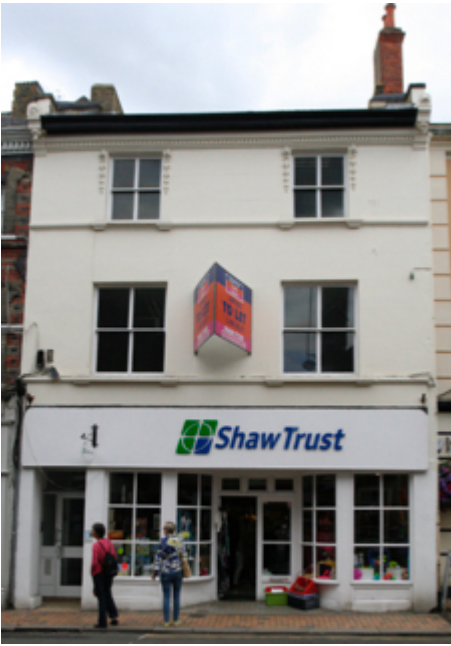
<p>27</p>	<p>Early twentieth-century shop with accommodation over. Stuccoed façade with neo-classical detailing. Good shop front with curved display windows. Corner of building supported on rusticated pier. Upper story retains 'Crittall' casement windows, first floor replaced with inappropriate uPVC glazing without glazing bars.</p>

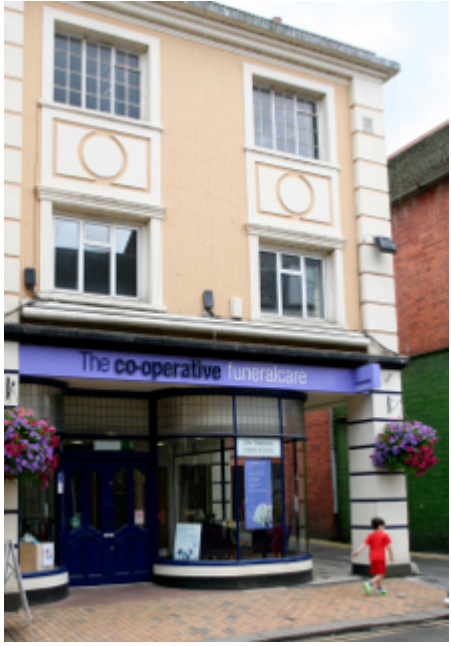
29	<p>1908 (date stone) shop with accommodation over. Red brick with stone details, green glazed tiles to the side suggests that the original shop front may have featured glazed tile detailing (possible dairy?). Bay window at first floor level with casements and glazing bars beneath a depressed segmental arch resting on short bulbous doric columns. Upper storey with Dutch gable and flanking oversize volutes. Upper window replaced with uPVC unit.</p>

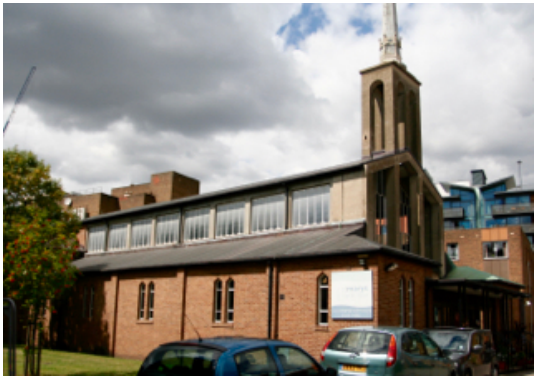
Church Hall	1908 Arts and Crafts church hall. Red brick with burnt headers creating checkerboard effect, lead lantern on roof. Unfortunate large modern window in end wall.

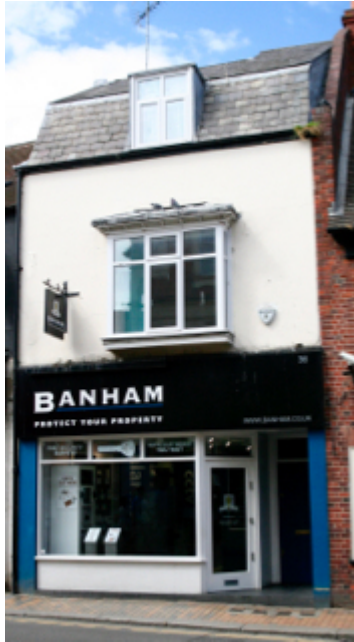
38	<p>Shop with accommodation over. Brick façade heavily painted. Sash windows mutilated. This unpromising looking building may contain important historic fabric. Historic photographs show that it was originally a double pile structure. Viewed from the back the roof, with a series of gabled dormers with 'Yorkshire sash' windows, would suggest that this is an eighteenth-century building.</p>

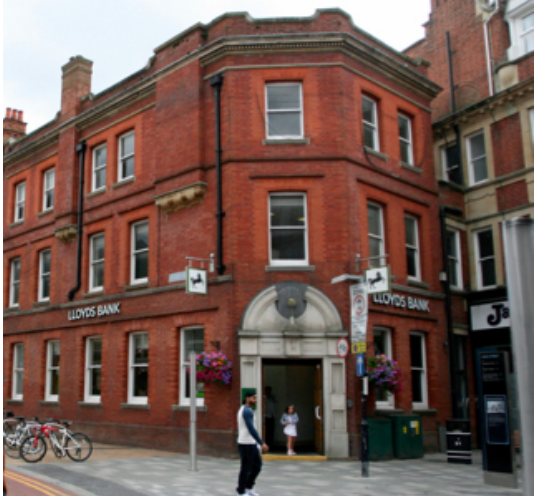
<p>47-51</p>	<p>Red brick and stone, 1903 Queen Anne revival shops with accommodation over. Notable features include the treatment of a corner site with copper roofed 'turret' room rising above the parapet with pairs of engaged classical columns between the windows. Original scale of shop front visible in alleyway.</p>

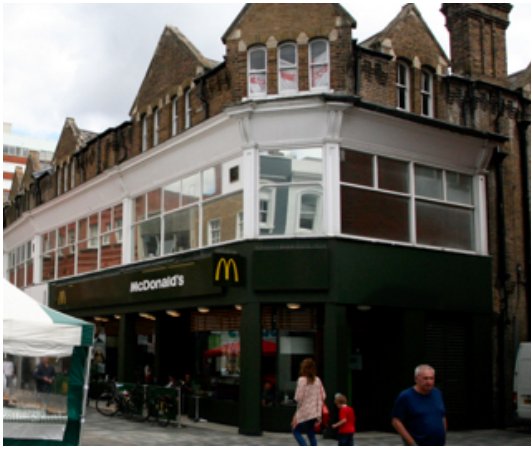
69-73	Cresset Towers 1892 by the Maidenhead Builders, J.K.Cooper and Sons. It has an asymmetrical design in red, hand-made bricks punctuated at the roofline with cupola turrets. Cresset Towers rises to three storeys, built in moulded red brick, terracotta ornaments and gauged brick niches. Architecturally is one of the most distinctive building in the High Street. Interestingly, the rear elevation was given a similarly detailed rich architectural treatment which still remains largely unaltered today.
